Journal of Rock Mechanics and Geotechnical Engineering

Mountain tunnel under earthquake force: A review of possible causes of damages and restoration methods

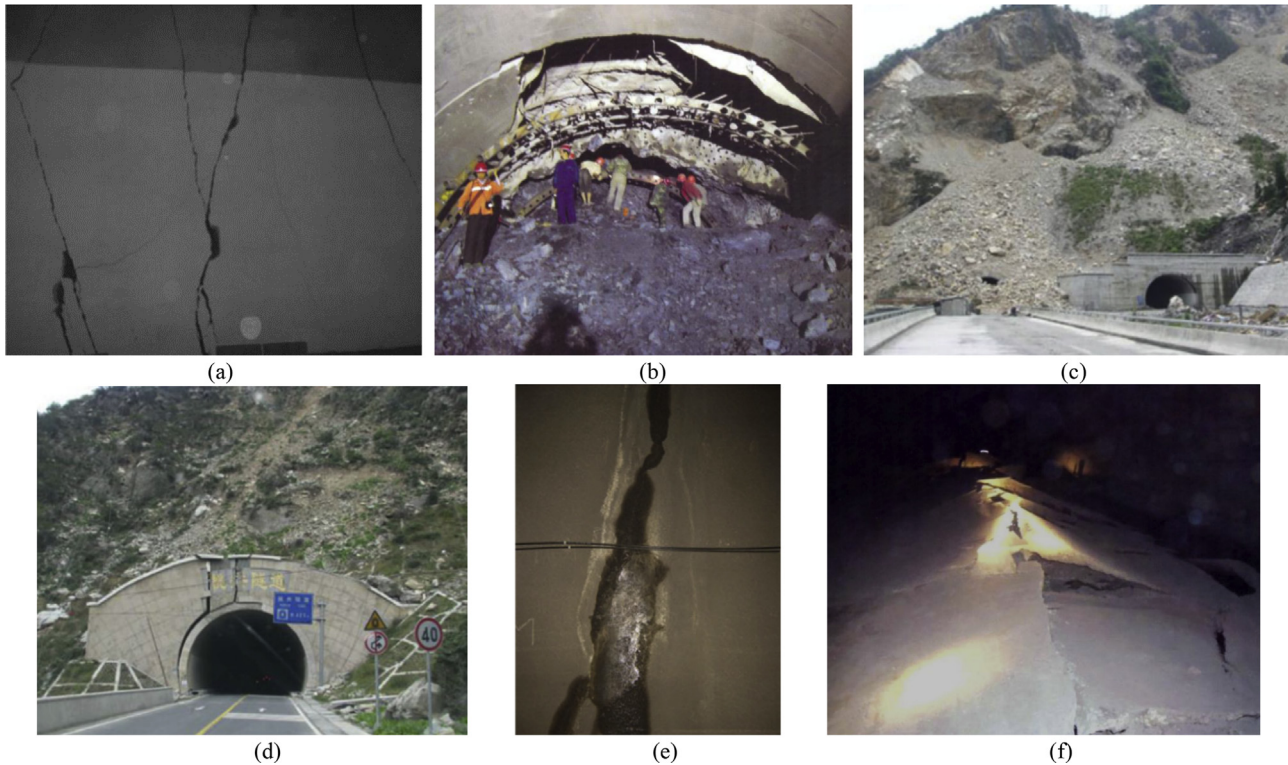
Fig. 1. Six most frequent damage characteristics of mountain tunnel subjected to earthquakes: (a) Lining cracks (Shen et al., 2014); (b) Shear failure of lining (Wang et al., 2001); (c) Collapse by slope failure (Li, 2012); (d) Portal cracking (Shen et al., 2014); (e) Groundwater leakage (Chen et al., 2012); and (f) Invert damage (Yu et al., 2016a).

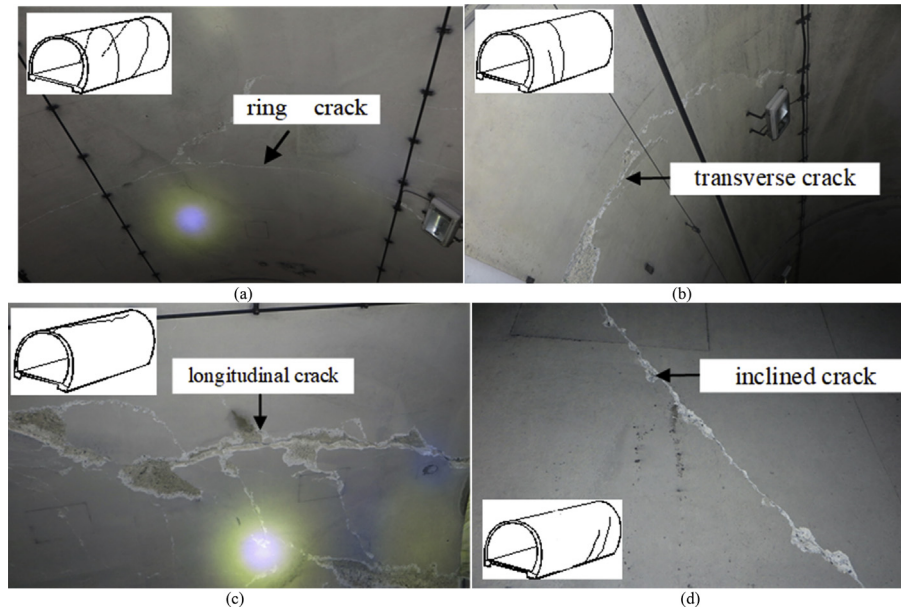
Fig. 3. Classification of cracks at Tawarayama tunnel subjected to the 2016 Kumamoto earthquake (after Zhang et al., 2018).

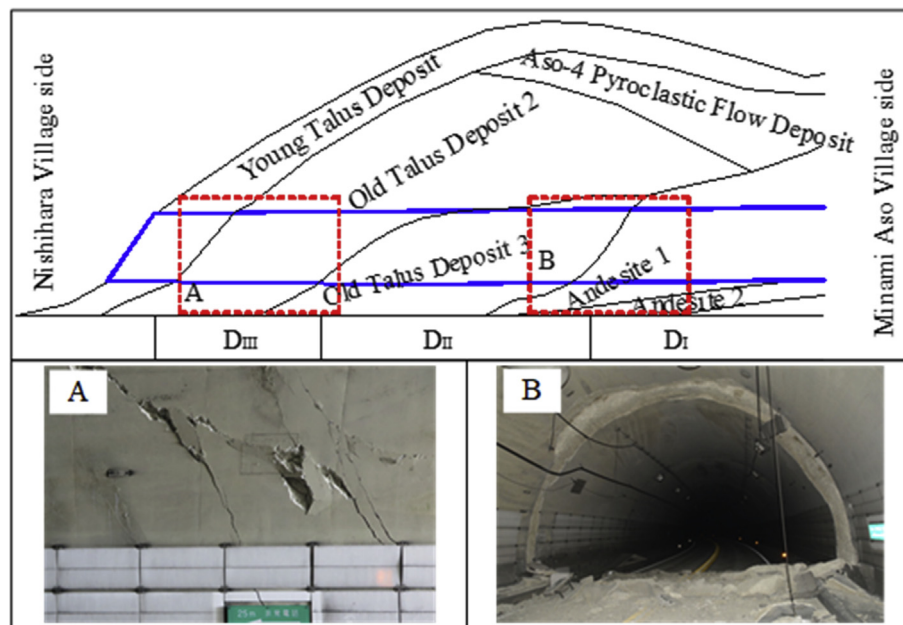
Fig. 8. Seismic damage at change zones between different grade rock masses.

Around Tawarayama tunnel, there are four types of rock grades categorized according to Japan Road Association (JARA) (2003): C_{II}, D_I, D_{II}, and D_{III}, as shown in Fig. 5. The condition of the rock mass is much worse as the grade number increases. When grounds with different rock grades meet around the tunnel, seismic damages suffered by tunnel structure during an earthquake usually occur due to the ground squeeze in soft ground or ground relative deformation at the intersection of different grounds. The damages at the western portal near the Nishihara Village side are the representative cases, as shown in Fig. 8.

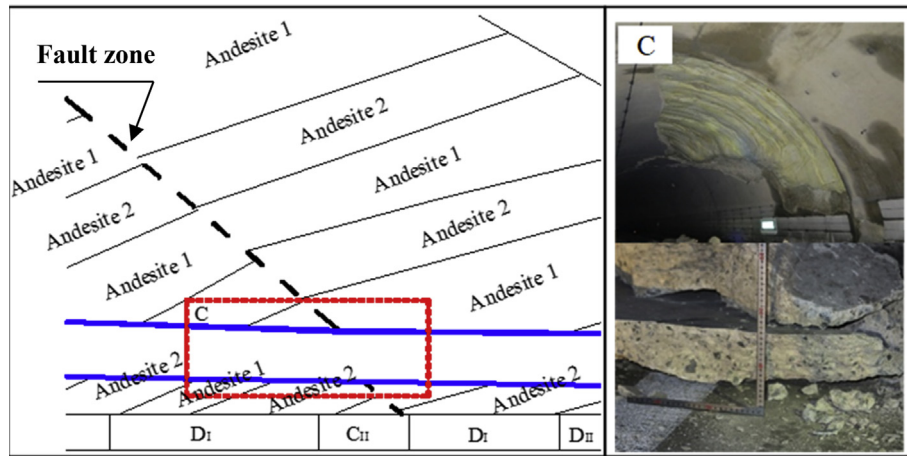
Fig. 9. Lining collapse at fault zone.

One fault was detected crossing the axis of the tunnel during the site investigation of Tawarayama tunnel, as shown in Fig. 9 (the black dashed line). The serious collapse of the secondary lining (S167) occurred due to the large shear movement of fault during the 2016 Kumamoto earthquake, as illustrated by Area C in Fig. 9. Besides, some gravel deposits at the waterproof for the span S167 were also observed. The contact between the primary and secondary linings was imperfect. The stress and displacement behaviors of tunnel lining strongly depend on the contact status (Son and Cording, 2007). The contact status between tunnel linings and that between tunnel lining and its surrounding rock is one significant factor that cannot be ignored for seismic performance of underground structure during an earthquake.

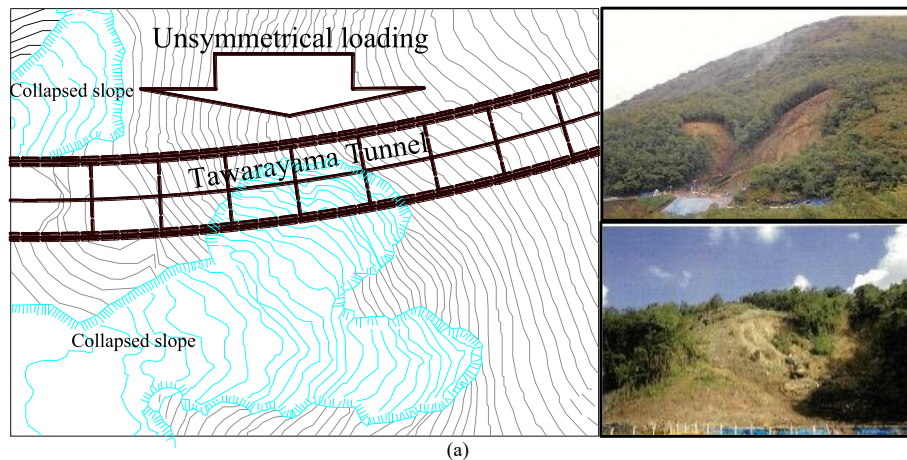
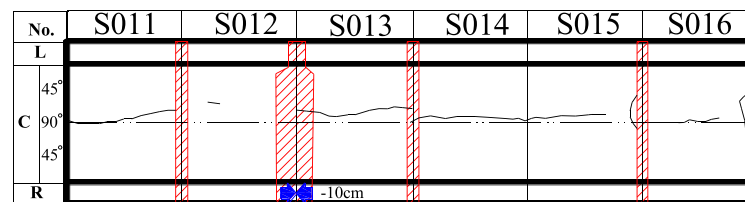
Fig. 10. Slope deformation in the Nishihara Village side (a) and resulting tunnel seismic damage (b).

Fig. 10 shows the slope deformation in the Nishihara Village side and resulting damages to Tawarayama tunnel. During earthquake, landslides occurred due to the unsymmetrical loading of the slope. As a result, the lining structure underneath the ground was forced to move 10 cm towards the southern direction (the direction of the landslide). Deformation due to compression and bending occurred, which even induced longitudinal crack and spalling of concrete lining, as shown in Fig. 10b. Moreover, the dislocation of the tunnel lining due to the southwestward movement contributed to uplift of the maintaining roadway at the left side.

With respect to the entrance of Tawarayama tunnel (at the Nishihara Village side), unsymmetrical loading of slope due to seismic loading induced serve deformation or even failure of the lining structure. Even worse, heavy rainfall caused collapse of part of the earthquake-induced loosen slope. The slope collapse aggravated the effect of unsymmetrical loading on the deformation of the lining structure. If the unsymmetrical loading is not addressed, the continuous pressure from the left side might induce continuous deformation by the aftershocks. Thus, there is a probability that secondary damage may occur. Excavation of the slope had to be conducted to relieve the unsymmetrical loading, as illustrated in Fig. 17. The earth at the upper side above the tunnel denoted by the blue area in Fig. 17 was removed. In addition, some loosen soil due to the earthquake was also removed to avoid secondary damage to the slope. After removal, a new ground surface noted by the red line in Fig. 17 was formed to relieve the unsymmetrical loading effect.

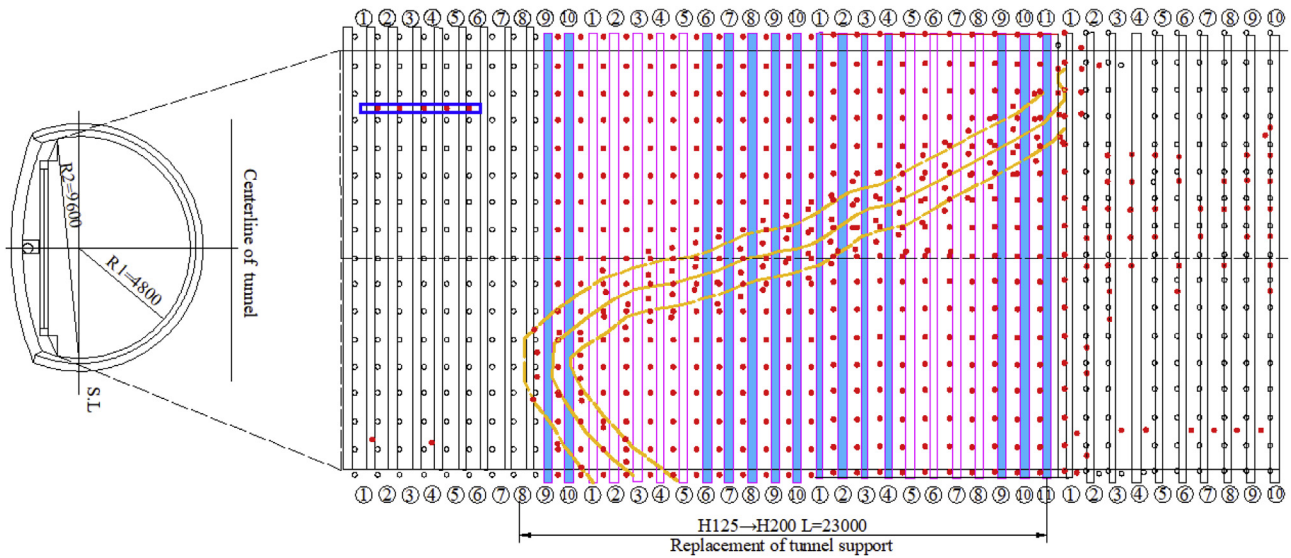
Fig. 14. Reconstruction of the lining from spans of S165 to S167 (unit: mm). Area with the yellow line is the fault zone behind the tunnel lining, red solid circle denotes the replaced rock-bolt, and blue lines denote the replaced steel arch.

The collapse of the lining structure (S167), buckling of steel support, and widespread spalling of the lining concrete (S012 and S028) deteriorated the bearing capability of the primary support and concrete lining. In spans from S165 to S167 with restoration level of RS, since the primary support and lining cannot function well with a very low capability, reconstruction is needed. Fig. 14 shows the reconstruction design for the lining from spans of S165 to S167. Due to 10 cm deformation both in transversal and longitudinal directions, the steel arch buckled severely (see Fig. 15), and replacement of the primary support was necessary. The rock-bolt (red solid circle in Fig. 14) and steel arch (blue line in Fig. 14) were replaced and the support pattern was changed from D_I to D_{IIIa} . On the other hand, removal of the failed steel support might affect the stability of the surrounding lining and ground and even induce secondary damage. Therefore, before removing the steel arch support, the injection type forepoling as an auxiliary method was conducted around the buckled areas to reinforce their stability.

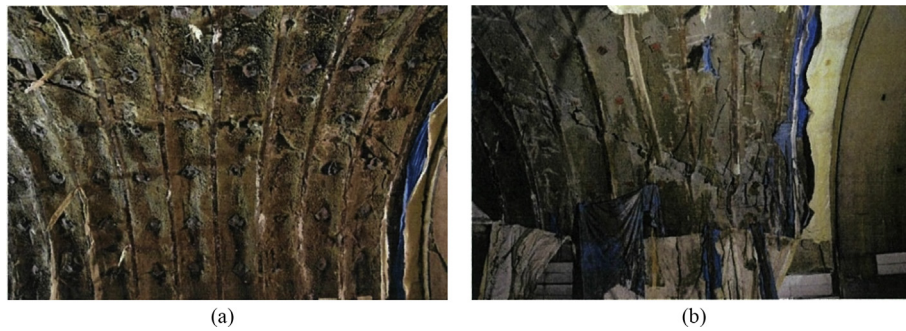
Fig. 15. Damage condition of steel support: (a) Right side of span S166, and (b) Left side of span S167.

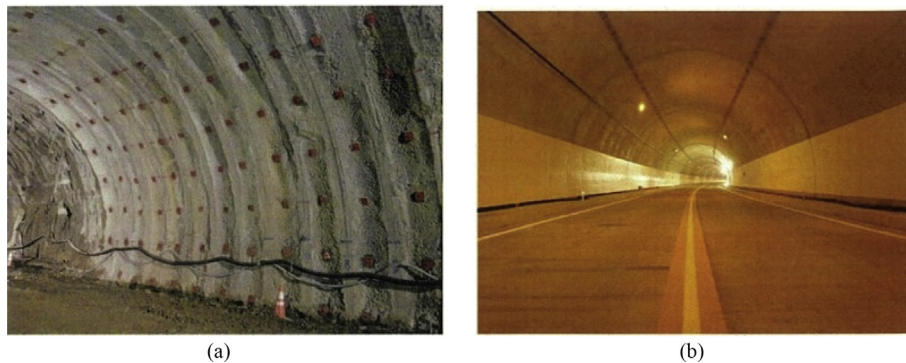
Fig. 16. Tunnel condition after reconstruction: (a) Condition after replacement of steel support at the left side in the spans of S166 and S167, and (b) Condition after reconstruction in the spans from S165 to S168.

Reconstructing the primary support such as steel support, shotcrete and rock-bolt should be evaluated with respect to their damage degrees. Since no obvious damage was observed for other 13 spans in restoration level RS, the steel arch support was left as it was. Only the failed shotcrete was replaced and then the number of rock-bolts was increased. For the reconstructed lining, concrete was reinforced with reinforcing steel bar of $\phi 19$ mm @ 200 mm as the primary reinforcement and $\phi 16$ mm @ 300 mm as the secondary one. In addition, the invert concrete of 6 spans (S012, S013 and S165–S168) with large deformation due to compression was also replaced by steel-reinforced concrete. Fig. 16 shows the tunnel condition after reconstruction.

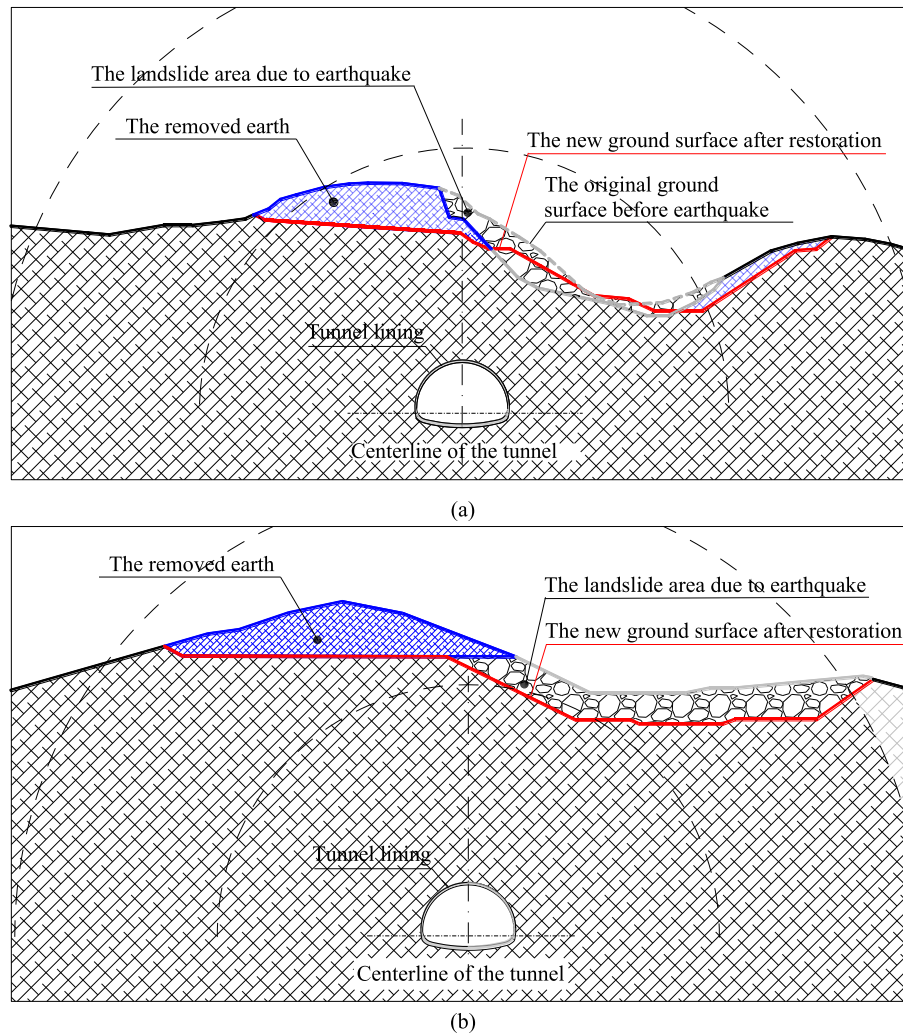
Fig. 17. Excavation of the slope: (a) Cross-section of spans S004 and S005, and (b) Cross-section of spans S006 and S007. Area within blue lines denotes removed earth.
