Journal of Rock Mechanics and Geotechnical Engineering

Mountain tunnel under earthquake force: A review of possible causes of damages and restoration methods

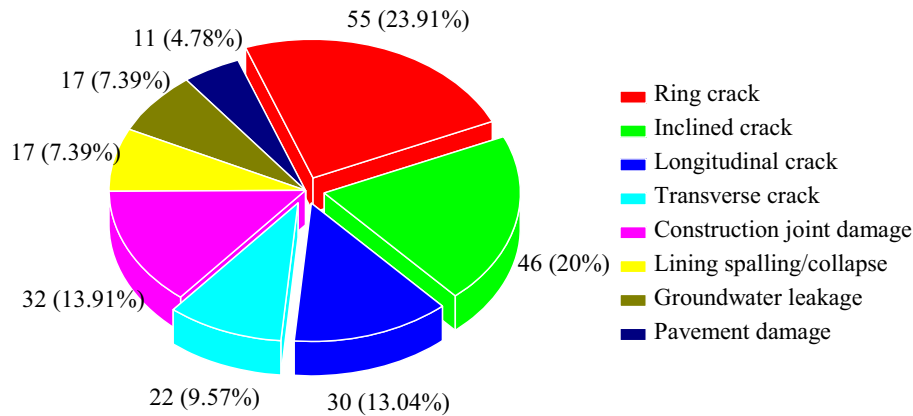
Zhang et al. (2018) classified the seismic damages to Tawarayama tunnel into five patterns: cracks of tunnel lining, damage of construction joint, groundwater leakage, spalling and collapse of concrete lining, and damage of pavement. Fig. 2 illustrates the statistic result of each seismic damage pattern. The crack of concrete lining is the most frequent characteristic of seismic damage, which can be as high as 66.53%. The cracks can be classified into ring crack (23.91%, see Fig. 3a), transverse crack (57%, see Fig. 3b), longitudinal crack (13.04%, Fig. 3c), and inclined crack (20%, Fig. 3d). Some occasional cases are construction joint damage, lining concrete spalling/collapse and groundwater leakage.

Fig. 2. Statistic result of each seismic damage pattern in Tawarayama tunnel.

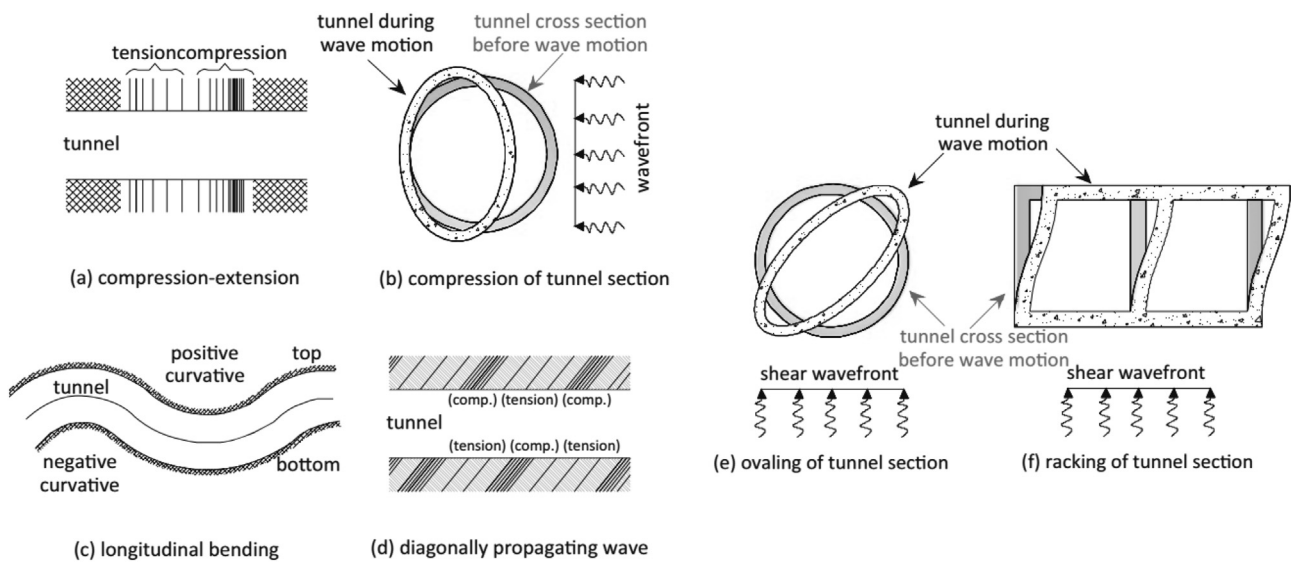
earthquake intensity of a particular area. The earthquake will be much more intense and its influence will be much stronger in the area with higher magnitude, shallower focal depth and shorter epicentral distance (Chen et al., 2012; Roy and Sarkar, 2017). In addition, Jiang et al. (2010) and Li (2012) focused on the influence of epicentral distance on seismic damage to the tunnel. On the other hand, the deformation mode and resulting damage to tunnels due to earthquakes are significantly influenced by the propagation direction of seismic waves (Li, 2012). Fig. 4 presents a simplified deformation mode of tunnels subjected to seismic loads. Three types of deformations could be used to express the effect of wave propagation direction on response of underground structure as follows: (1) axial compression and extension (Fig. 4a, b and d); (2) longitudinal bending (Fig. 4c); and (3) ovaling/racking (Fig. 4e and f) (Owen and Scholl, 1981; Maugeri and Soccodato, 2014).

Fig. 4. Simplified deformation modes of tunnels due to seismic waves (Owen and Scholl, 1981; Maugeri and Soccodato, 2014).

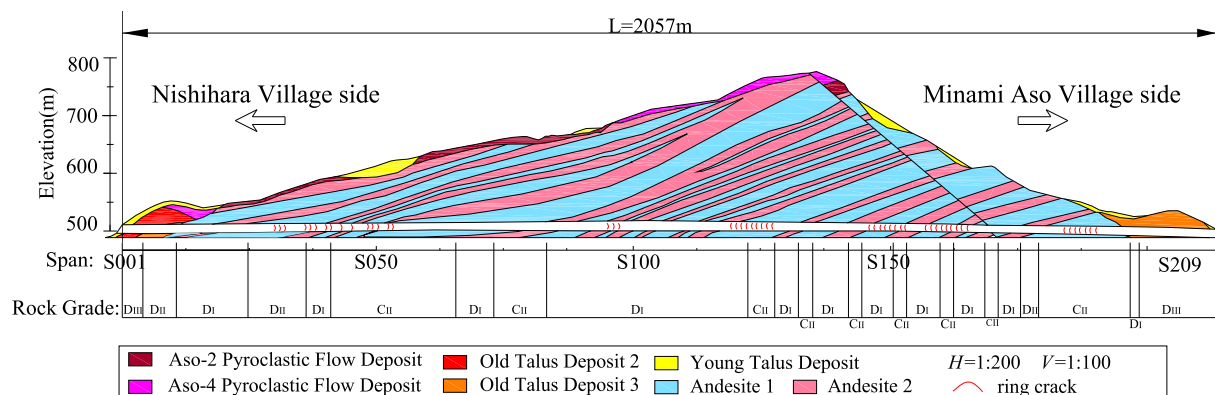
Fig. 5. Geological profile of Tawarayama tunnel. Based on Japan Road Association (JARA) (2003), rock mass along the tunnel is divided into four classes: CII, DI, DII, and DIII (Zhang et al., 2018). S is the short for span.

Around Tawarayama tunnel, there are four types of rock grades categorized according to Japan Road Association (JARA) (2003): C_{II}, D_I, D_{II}, and D_{III}, as shown in Fig. 5. The condition of the rock mass is much worse as the grade number increases. When grounds with different rock grades meet around the tunnel, seismic damages suffered by tunnel structure during an earthquake usually occur due to the ground squeeze in soft ground or ground relative deformation at the intersection of different grounds. The damages at the western portal near the Nishihara Village side are the representative cases, as shown in Fig. 8.

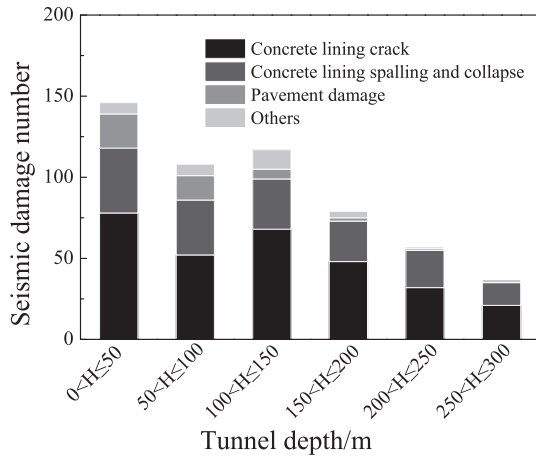
Fig. 6. Relationship between burial depth of Tawarayama tunnel and resulting seismic damages due to the 2016 Kumamoto earthquake.

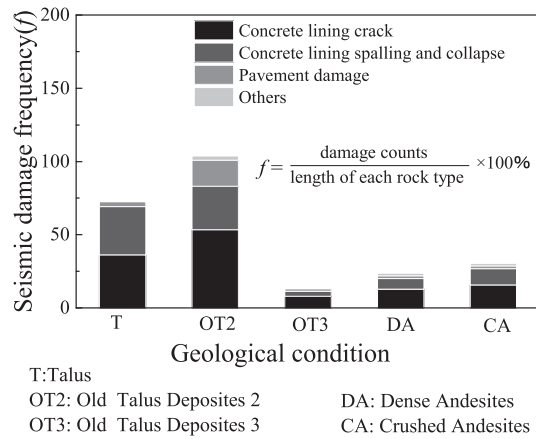
Fig. 7. Relationship between rock type and seismic damage frequency in Tawarayama tunnel subjected to the 2016 Kumamoto earthquake.

volcanic ash clayed soil) and old talus deposit (old talus deposit 2 is welded tuff, and old talus deposit 3 is welded pyroclastic flow containing a large amount of scoria). Besides, andesite lava is the most common for the other section of the tunnel. A ratio of seismic damages and length of each rock type that the tunnel crosses is defined as seismic damage frequency f . Fig. 7 presents the relationship between rock type and seismic damage frequency in Tawarayama tunnel subjected to the 2016 Kumamoto earthquake. Due to large damping and limited capability to constrain the lining structure of loose deposits and broken rock masses (i.e. talus and old talus deposits at the portal of Tawarayama tunnel) with low strength surrounding the tunnel, seismic damages occurred more frequently with relatively high seismic frequency. For andesite in the deeper mined part, tunnel structures in the crushed one are more vulnerable to seismic damages than those in the dense one due to the poor mechanical properties of the crushed andesite.

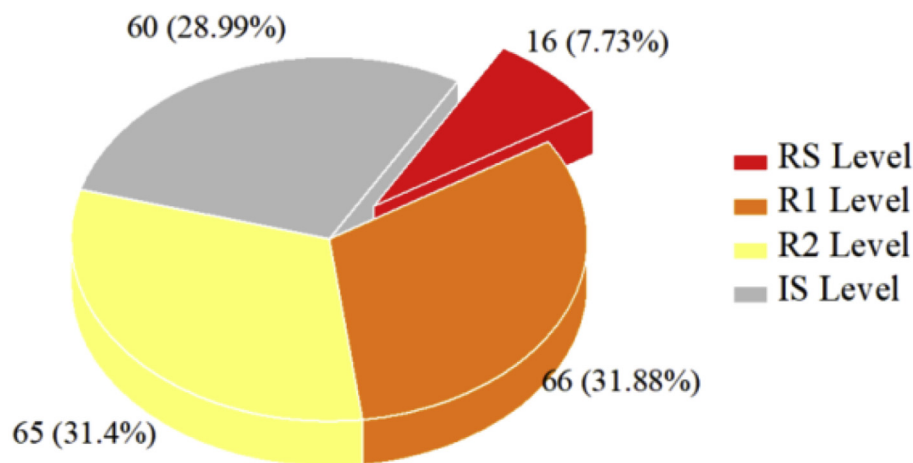
Fig. 13. Span percentage of each restoration countermeasure for Tawarayama tunnel.

Two hundred and seven (207) spans of Tawarayama tunnel were investigated based on the proposed design criterion. Fig. 12 shows the restoration level at each span in the tunnel. Reconstruction is needed in the portal (S001) and the spans with lining spalling/collapse and other large deformation (S004, S005, S010, S012, S013, S028, S029, S096, S097, S158, S159, S165, S166, S167, and S168). In total, there are 16 spans among the 207 spans that need to be reconstructed. Except for the portal (span S001), lining concrete of other spans with the requirement for reconstruction was removed to provide a direct visual inspection on the steel arch support. Moreover, the pavement in 11 spans among the 16 spans was also removed. On the other hand, 66 and 65 spans are in the restoration levels of R1 and R2, respectively. No special restoration is required for 60 spans. Fig. 13 shows the statistics for spans with each restoration design level for Tawarayama tunnel. Based on the restoration level and specific condition of each damaged lining span, repair and reinforcement measures are determined. Table 3 summarizes the specific restoration measures adopted for Tawarayama tunnel.
